# STREETSCAPE AUDIT

## Pakington Precinct

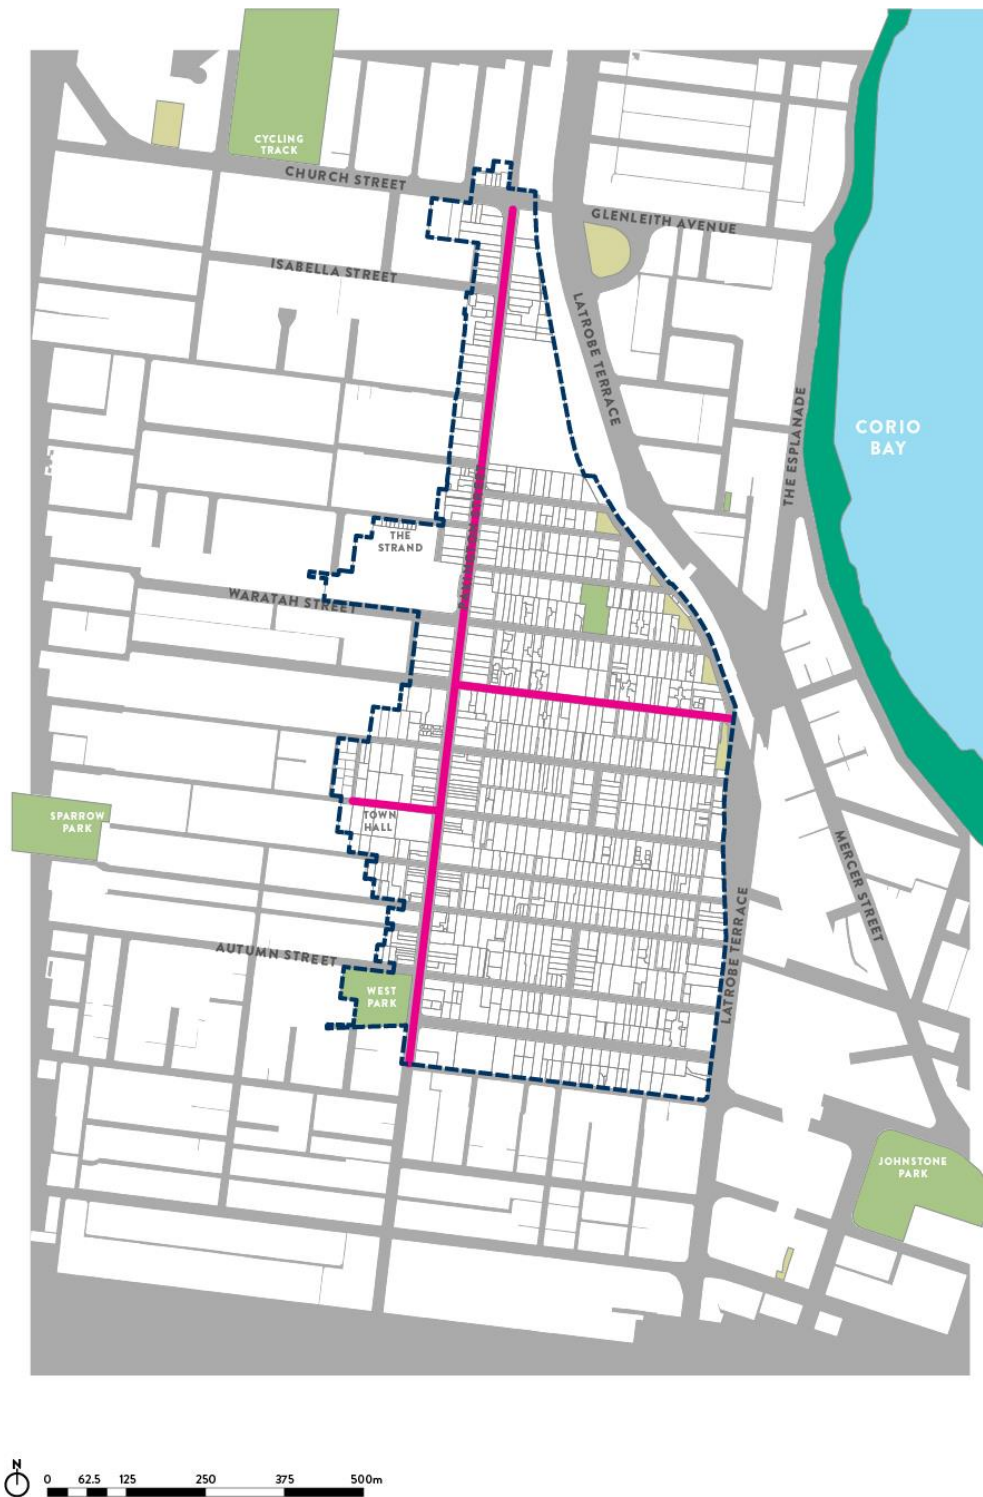
Figure 1 Audit area, Pakington Street

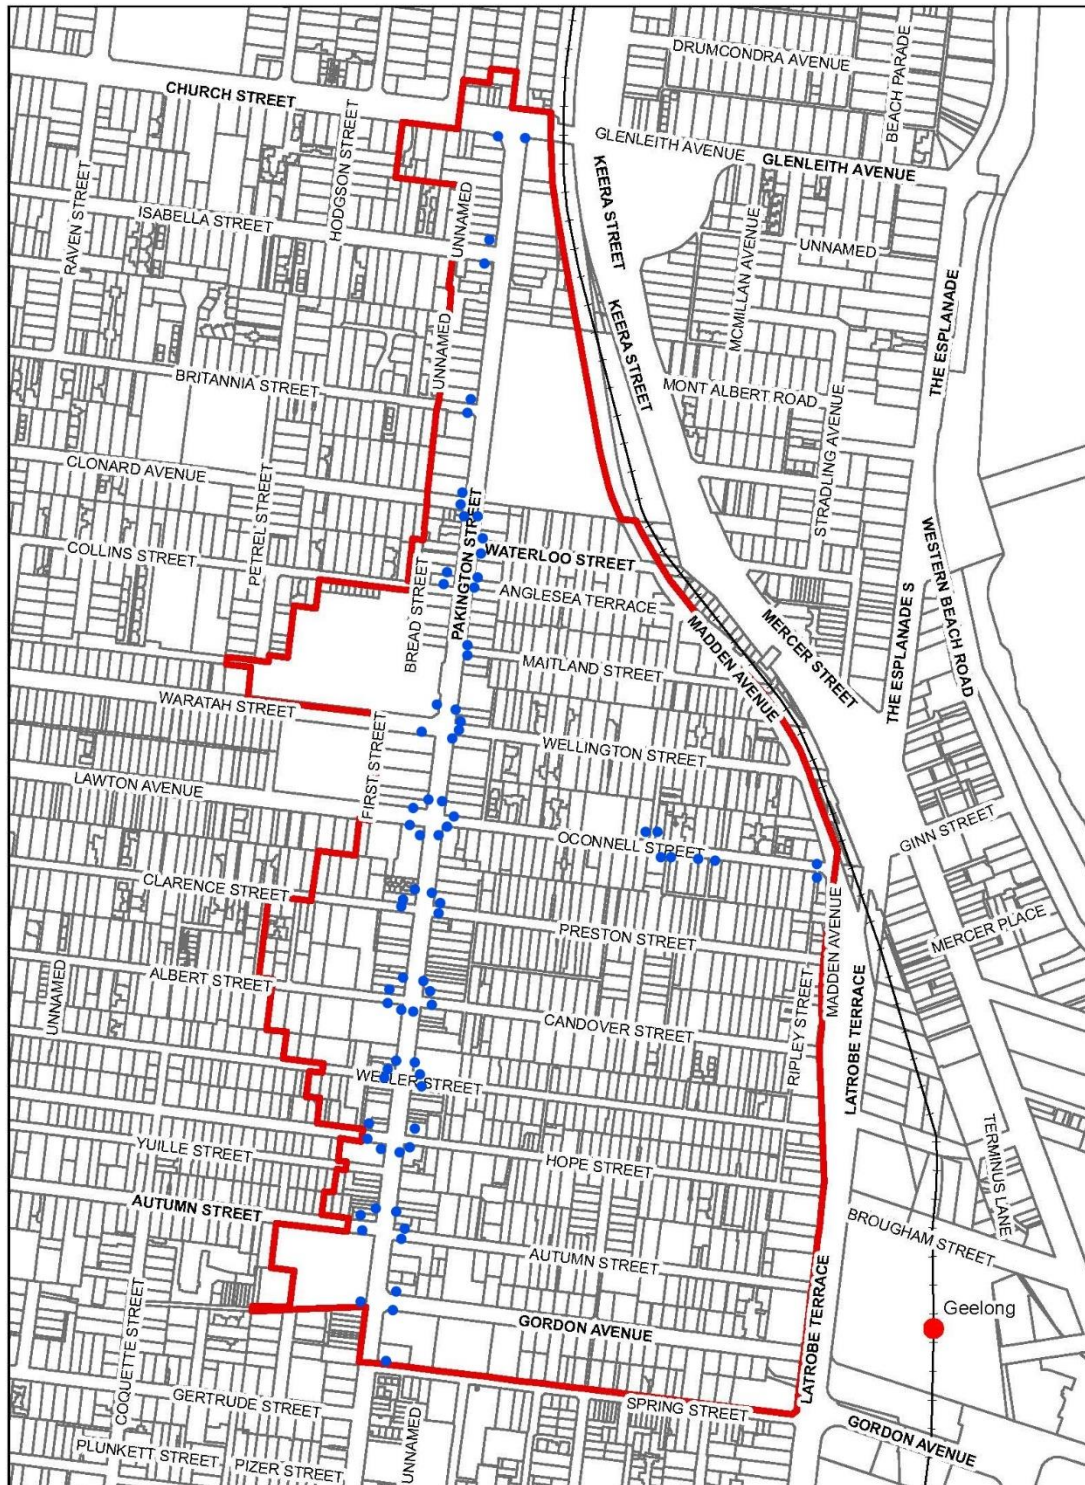
Figure 3 Non-compliant pedestrian crossings

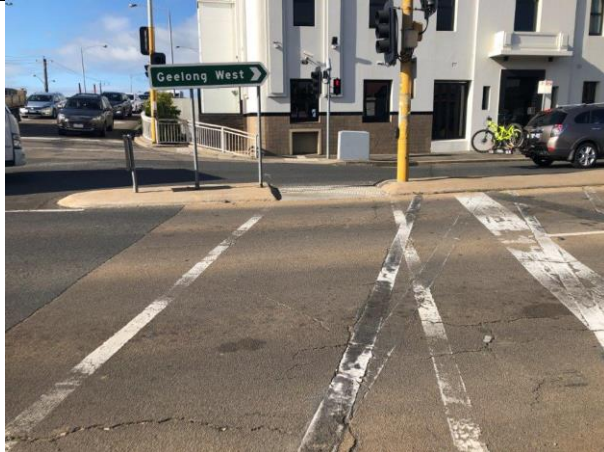
General view from mid-point crossing to Pakington Street east

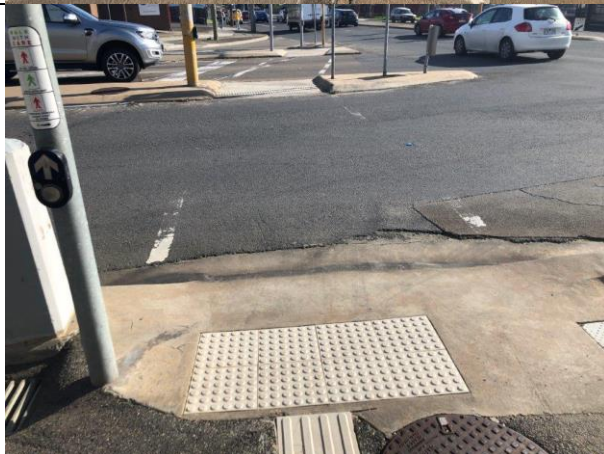
General view from Pakington Street east to mid-point crossing; footpath graded to carriageway, gradient 6.9%

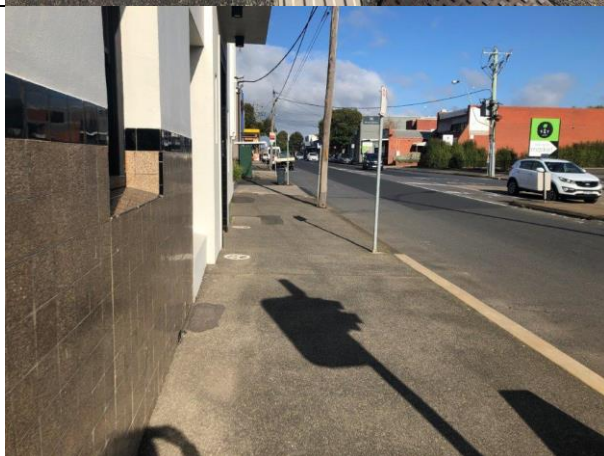
- × Worn missing lines
- × TGSIs - Poor luminance contrast
- × Uneven surface

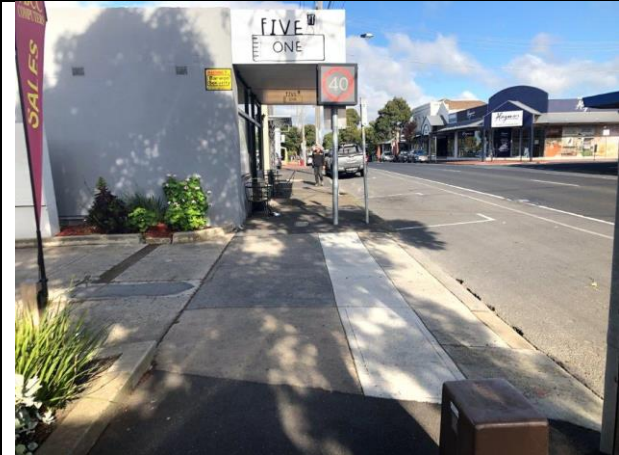
Typical concrete crossover  
 × Crossfalls 4.9%, in excess of 2.5% for concrete

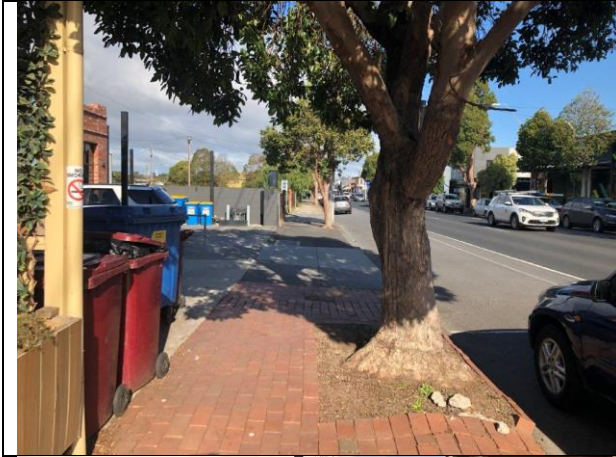
- × Damage to brick footpath and uneven surface from street trees

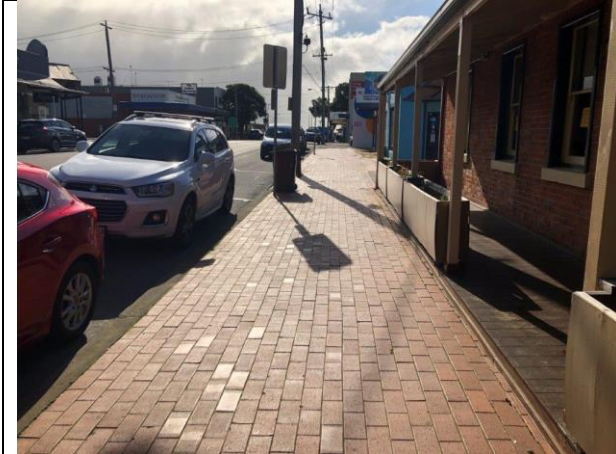
- × Cross falls approx. 4.3%, in excess of 2.5% for non-asphalt surface

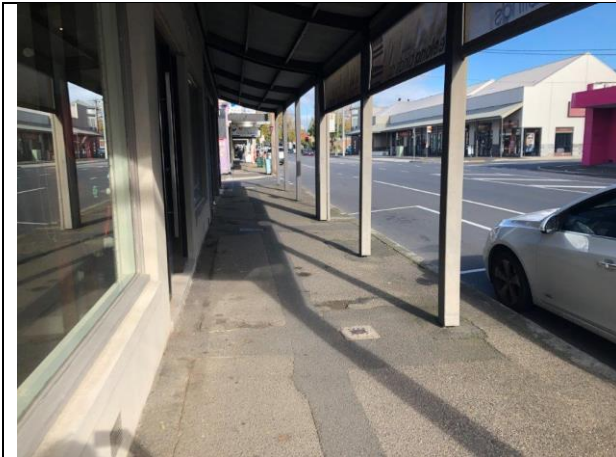
General view  
 × Some unevenness and localised damage to asphalt

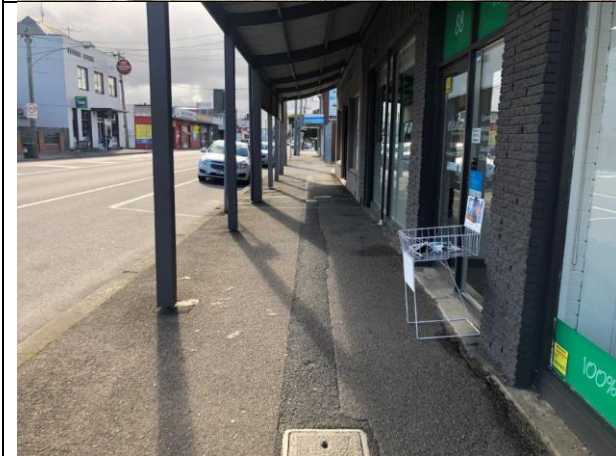
General view  
 × Some unevenness and localised damage to asphalt

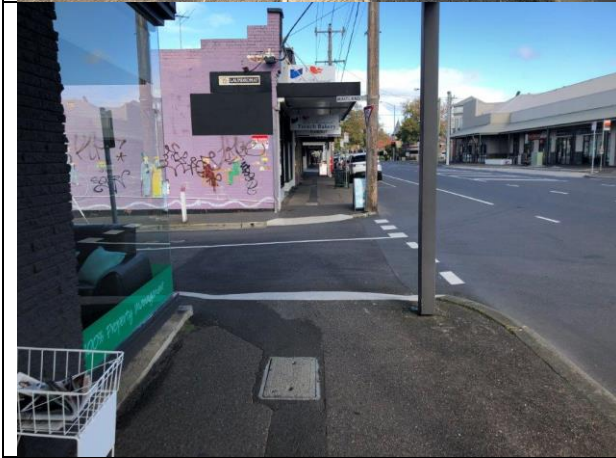
View across Maitland Street, kerb cut gradient 13.9%  
 × No TGSIs  
 × Incorrect geometry for kerb ramp

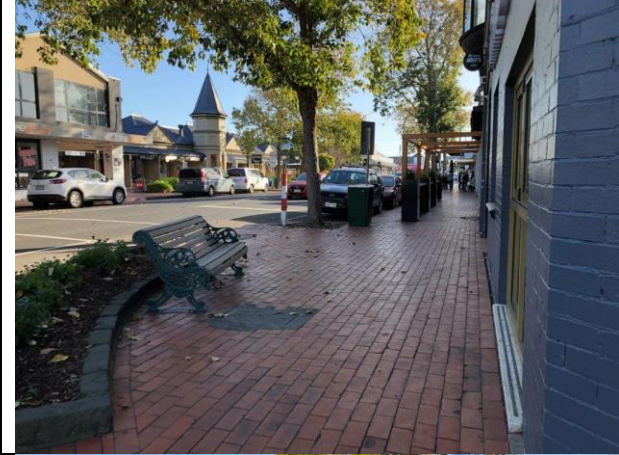
- × Footpath grades down to carriageway, gradient approx. 2.1%, with cobbled edge and lip edge.
- × No TGSIs
- × Some unevenness in brick evident

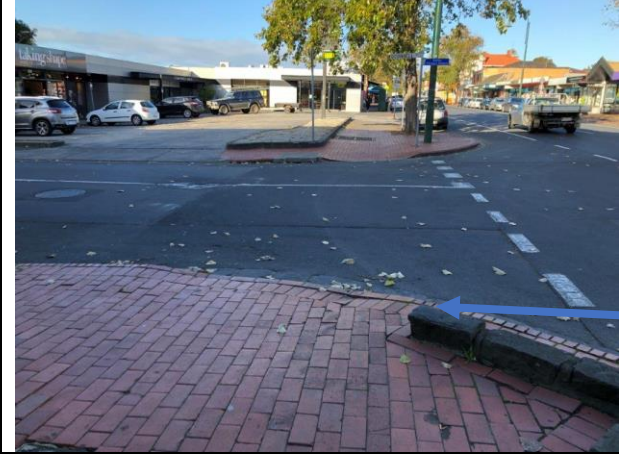
View across O'Connell Street.

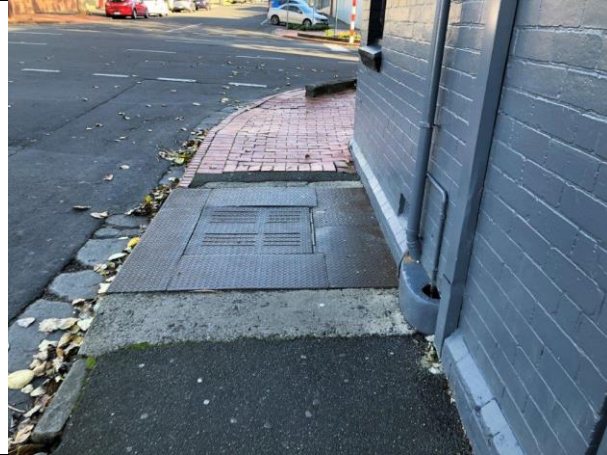
- × Uneven brick surface
- × Uneven cellar (?) access point creating trip hazard

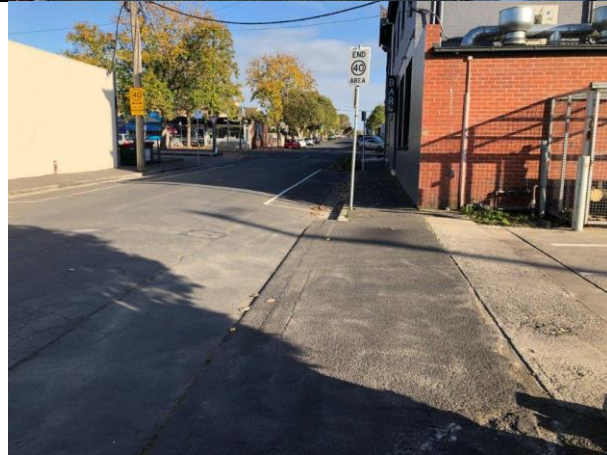
Wide asphalt crossover servicing rear carpark

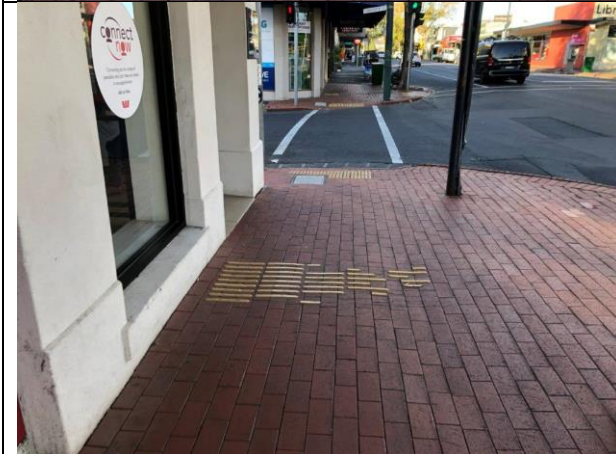
View across Candover Street.

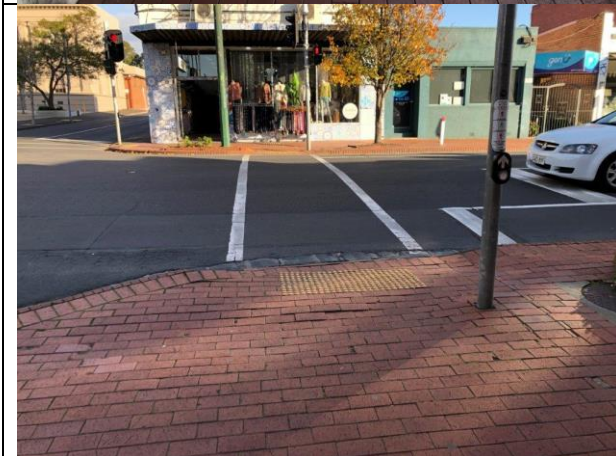
Controlled crossing across Pakington Street.

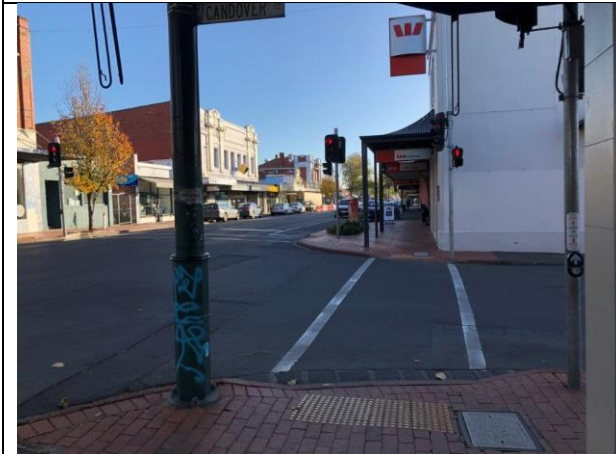
View across Candover Street.

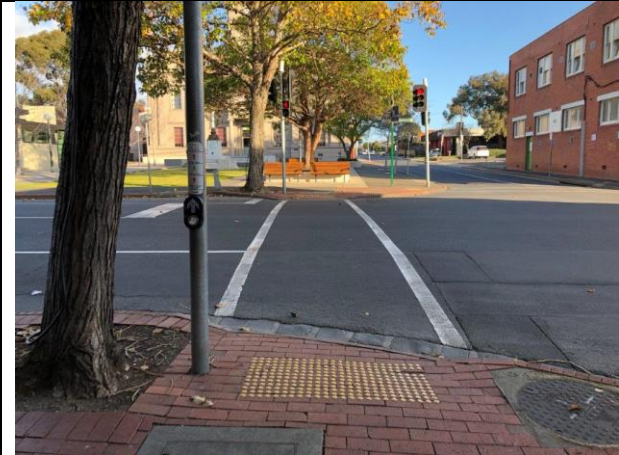
Controlled crossing across Pakington Street.

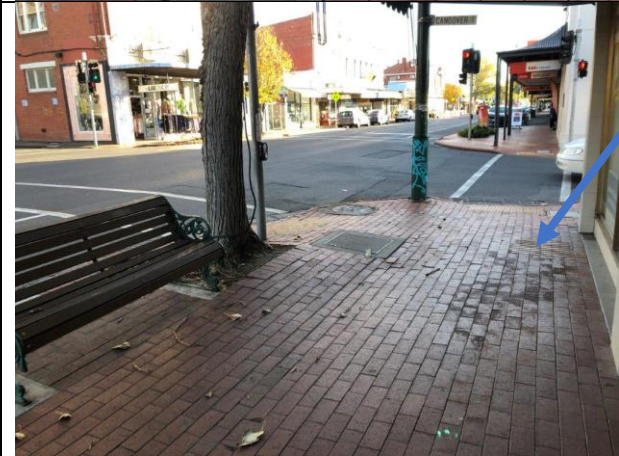
- × Damaged TGSIs that no longer link to pedestrian crossing.
- × Brick surface uneven adjacent tree

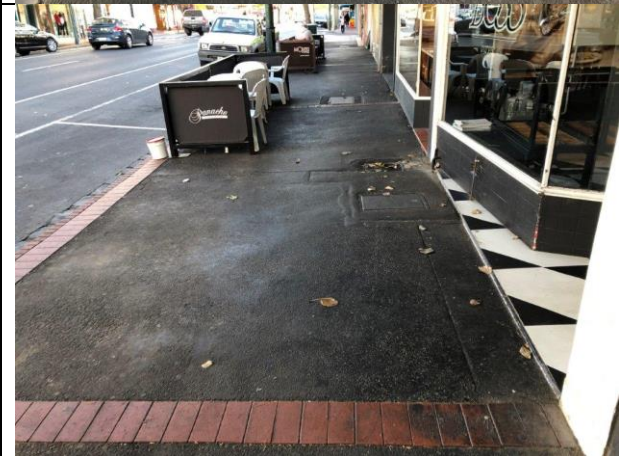
General view.  
 × Uneven repairs adjacent utility covers

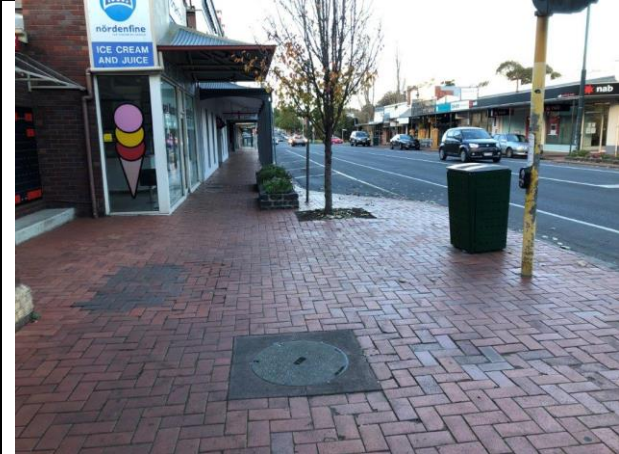
- × General unevenness in brick finish
- × Footpath grades down to carriageway with gradient approx. 0.3%, with cobbled edge and 30mm lip edge
- × No TGSIs

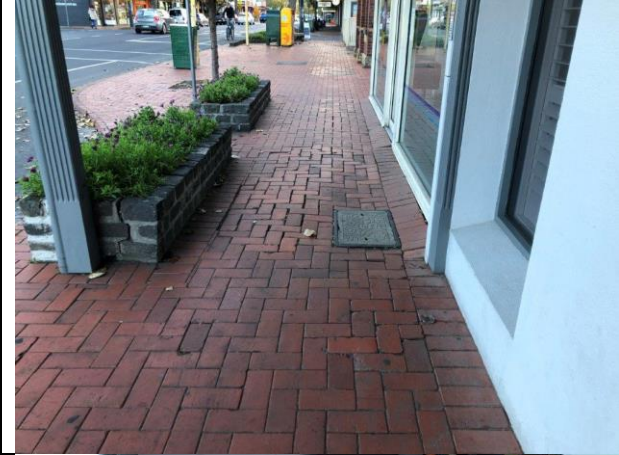
- × Generally uneven finishes, patch repairs

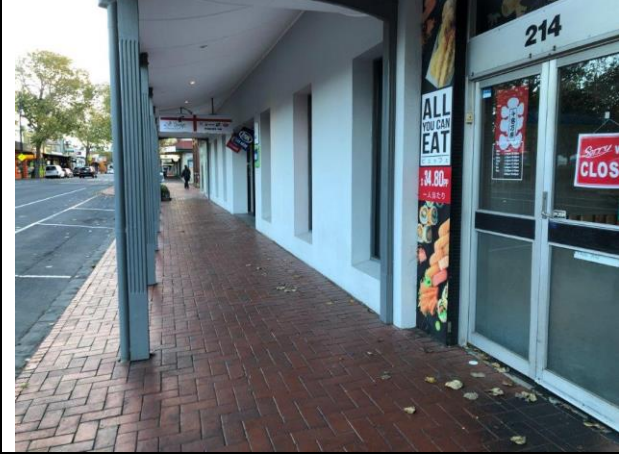
- × Generally uneven finishes, patch repairs
- × Planter cracked

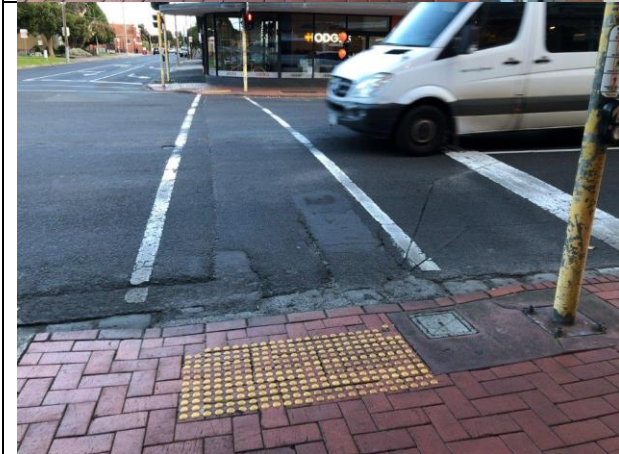
Controlled crossing across Pakington Street.

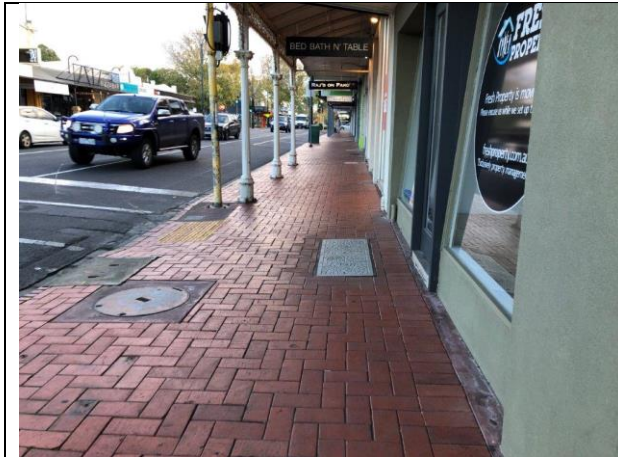
General view of controlled crossing

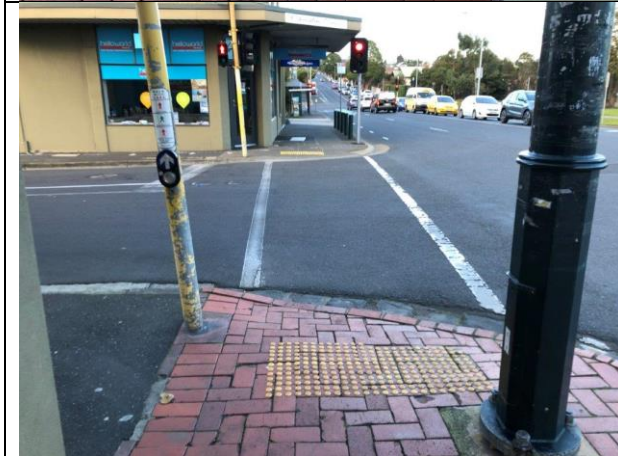
View across Autumn Street.

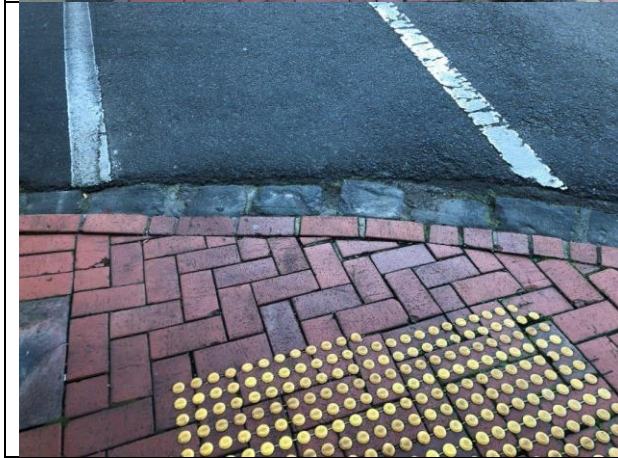
Close up of uneven bricks and cobbled kerb treatment

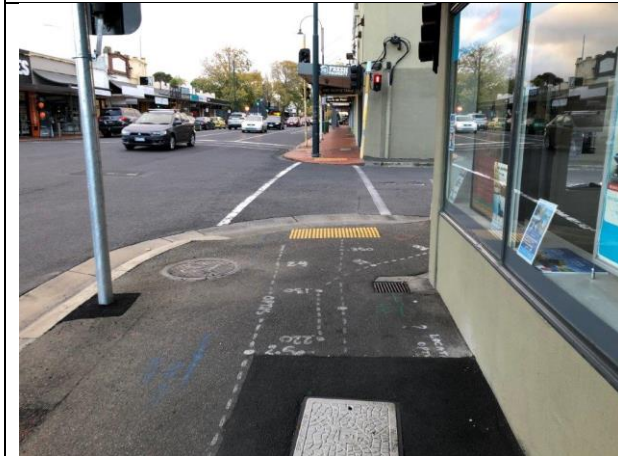
View across Autumn Street, footpath grades down to carriageway with gradient approx. 3.8%.

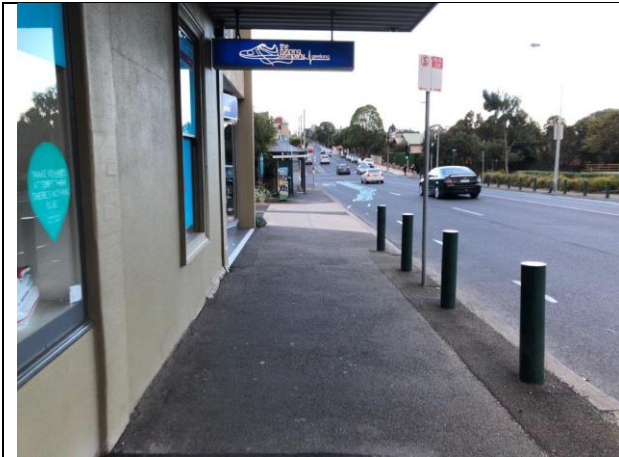
- ✓ TGSIs provided
- ✓ TGSIs adequate luminance contrast
- ✓ TGSIs aligned path of travel
- × Kerb cut not aligned with path of travel
- × Multiple repairs around utility covers impact visual aesthetic

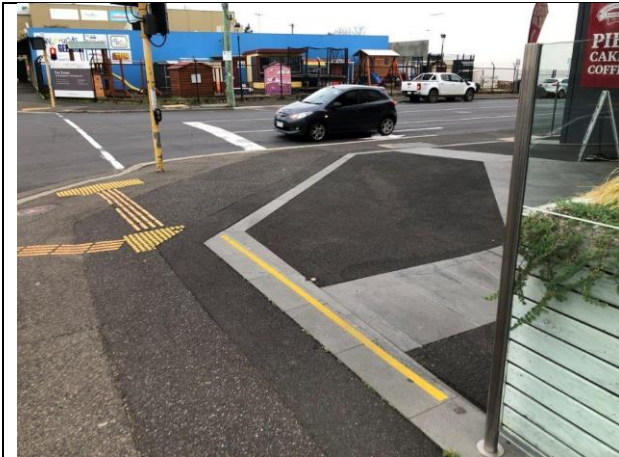
- × Step at building line, potentially confusing as footpath continues at grade on splayed section and along Spring Street
- × TGSIs not reinstated after asphalt repair

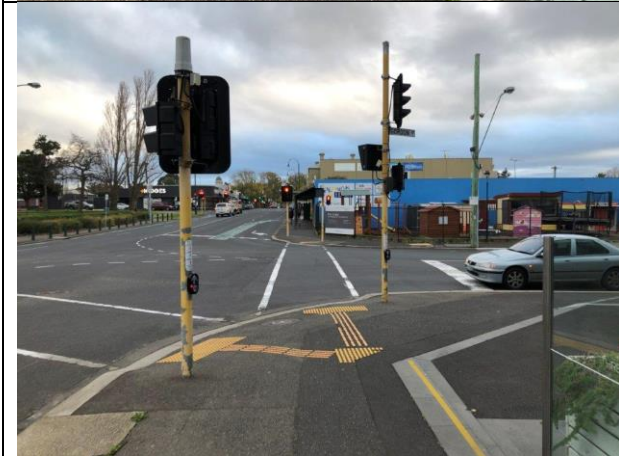
- Controlled crossing across Gordon Street, footpath graded to carriageway
- ✓ TGSIs adequate luminance contrast
  - ✓ TGSIs aligned path of travel
  - × Kerb cut not aligned with path of travel
- Controlled crossing across Pakington Street.
- ✓ TGSIs provided
  - ✓ TGSIs adequate luminance contrast
  - ✓ TGSIs aligned path of travel

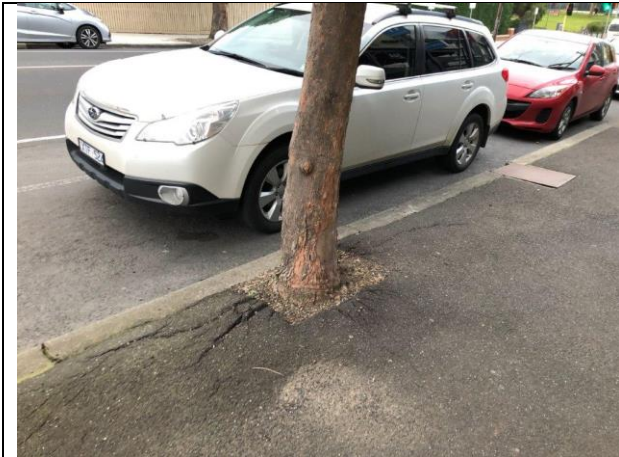
× Damaged asphalt adjacent tree

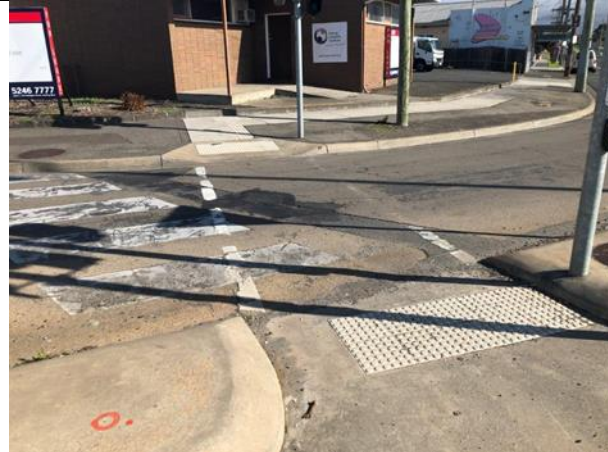
- General view from mid-point crossing to Pakington Street west
- ✓ TGSIs provided
  - ✓ TGSIs aligned path of travel

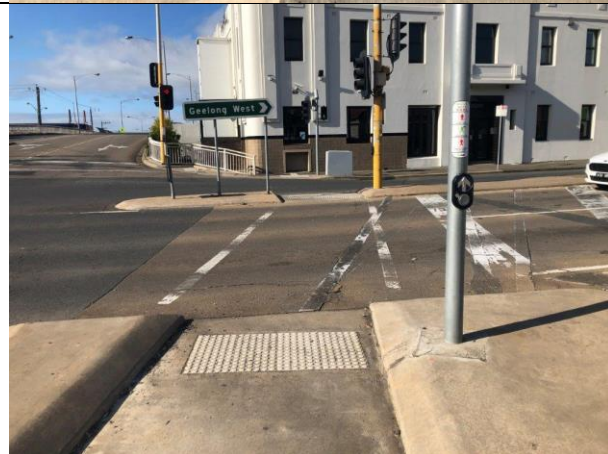
- General view from mid-point crossing to Pakington Street west
- ✓ TGSIs provided
  - ✓ TGSIs aligned path of travel

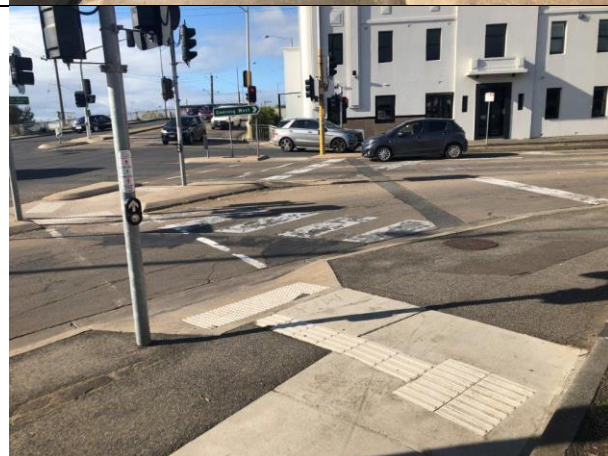
- General view to mid-point crossing from Pakington Street west
- ✓ TGSIs provided
  - ✓ TGSIs aligned path of travel

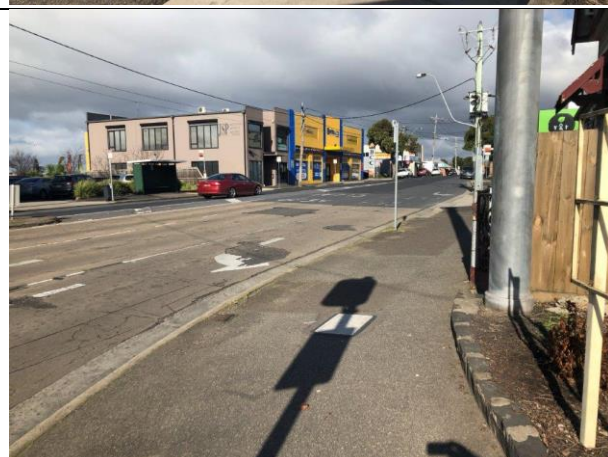
General view looking south – uneven asphalt surface

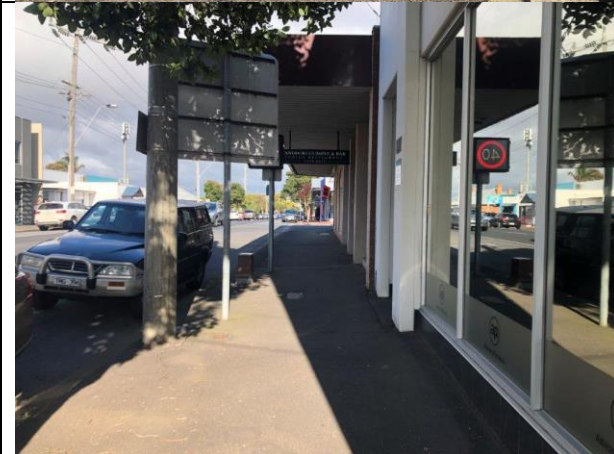
General view – asphalt damaged adjacent tree

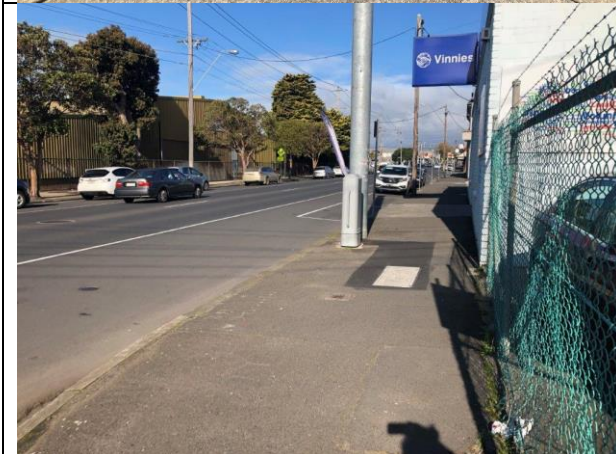
**General view. Repairs adjacent to utility covers.**

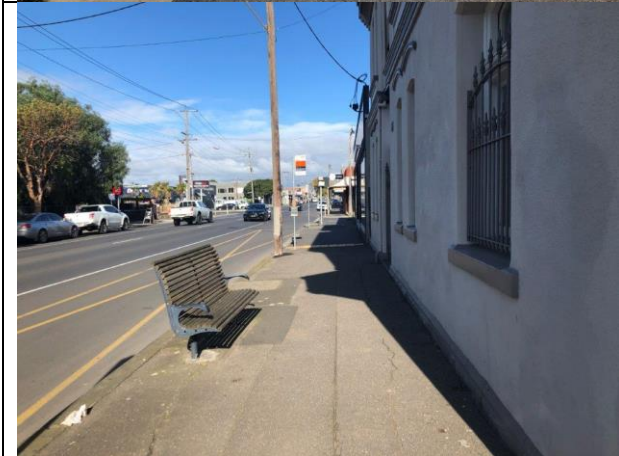
General view. Cracked and repaired asphalt.

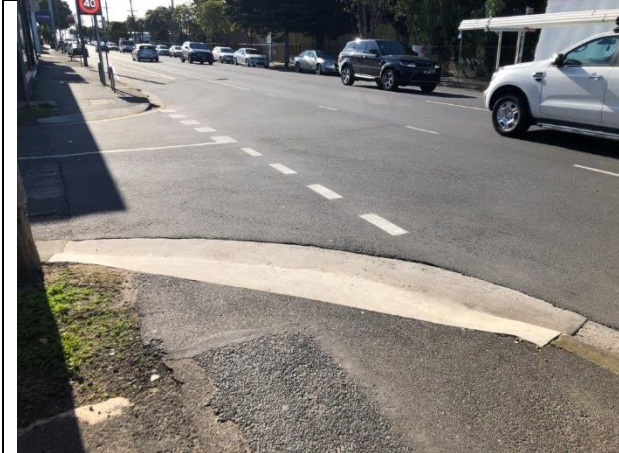
Crossing across Clonard Avenue, footpath grades down to carriageway with gradient approx. 17.3%

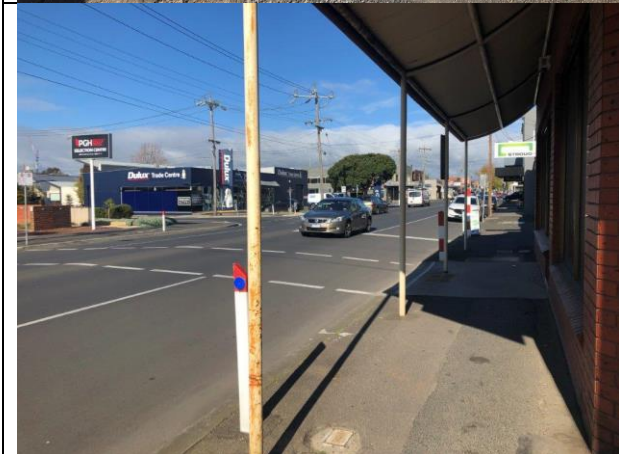
- × No TGSIs
- × Kerb cut not aligned with path of travel
- × Uneven footpath adjacent repair

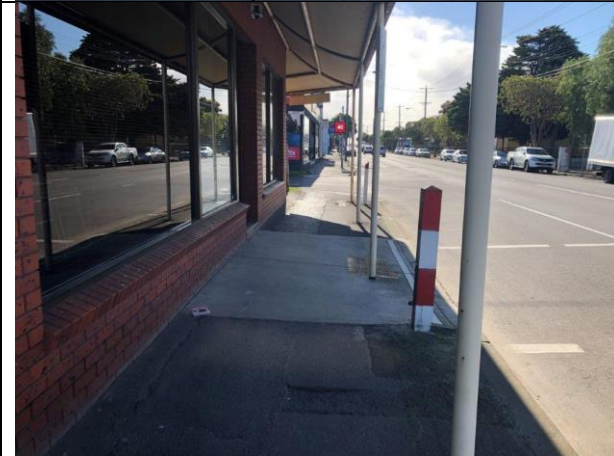
General view – multiple asphalt repairs

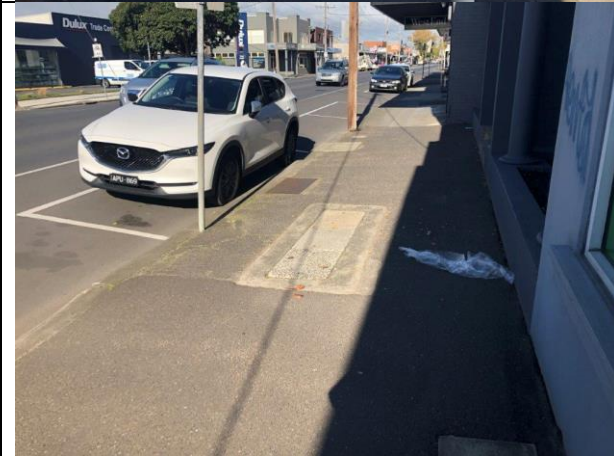
General view – multiple repairs adjacent utility covers

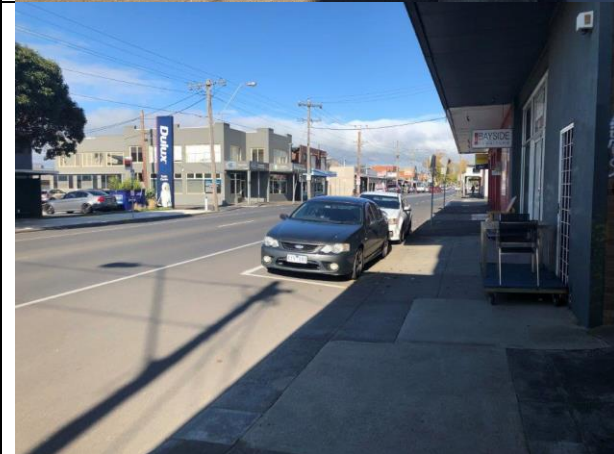
General view – multiple repairs

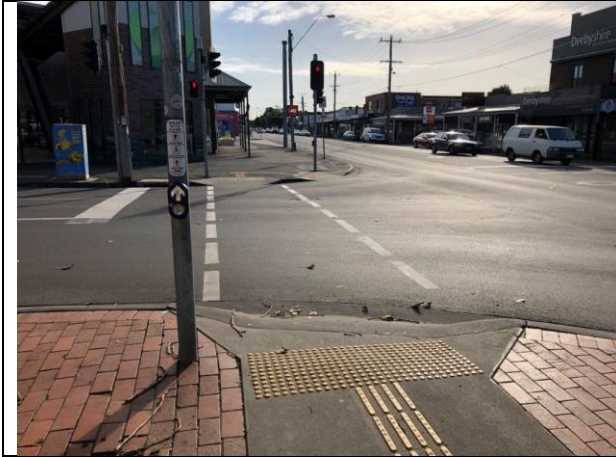
Controlled crossing across Waratah Street, footpath grades down to carriageway with gradient approx. 8.3%

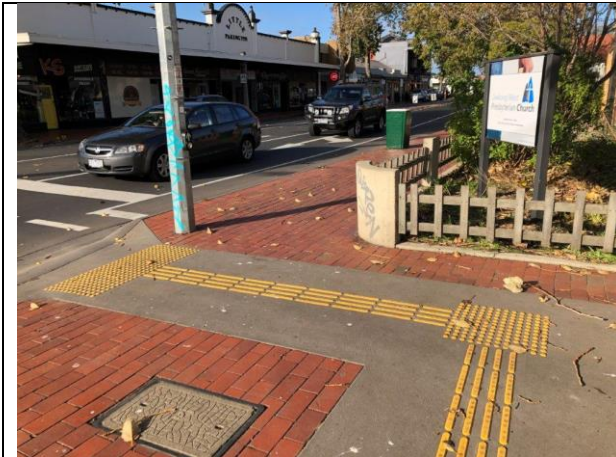
- ✓ TGSIs provided
- ✓ TGSIs aligned path of travel
- × Kerb cut not aligned with path of travel
- × TGSIs likely inadequate luminance contrast

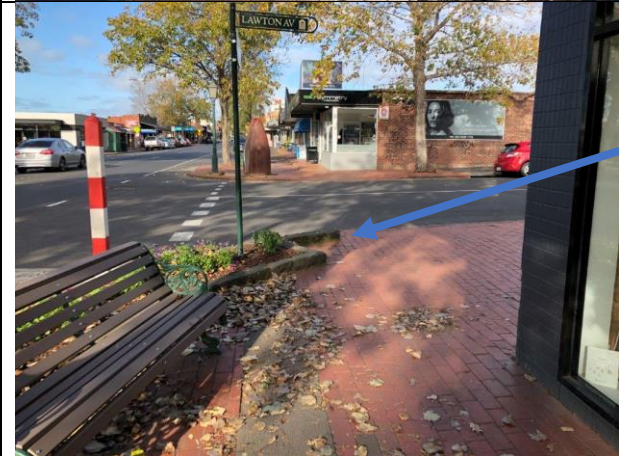
General view  
 × Extension of planter edging creating trip hazard

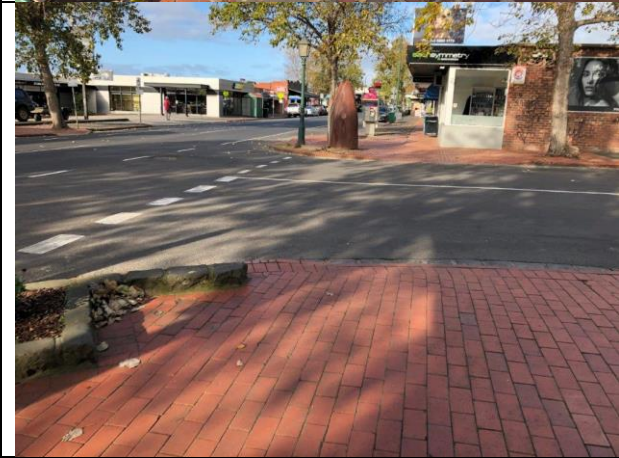
Crossing across Lawton Street, footpath grades to carriageway, gradient approx. 4.6%  
 × No TGSIs  
 × Planter edging creating trip hazard  
 × Cobbled kerb detail with lip edge

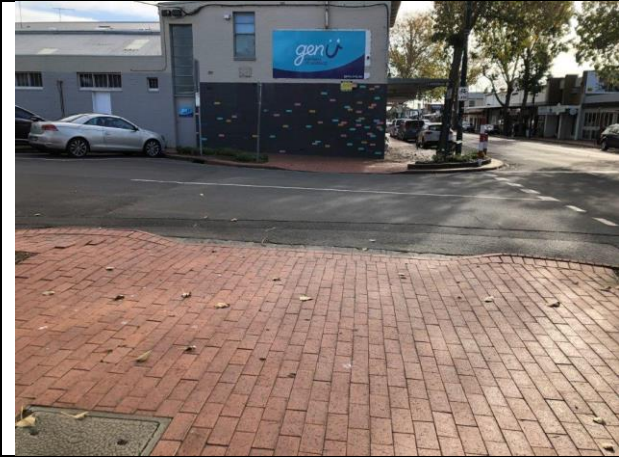
Crossing across Lawton Street, footpath grades down to carriageway with gradient approx. 2.3%  
 × No TGSIs  
 × Cobbled kerb detail with lip edge

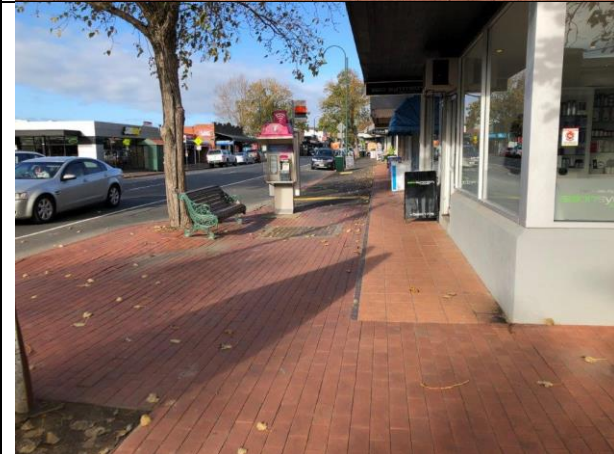
General view with raised section of retail frontage adjacent the footpath

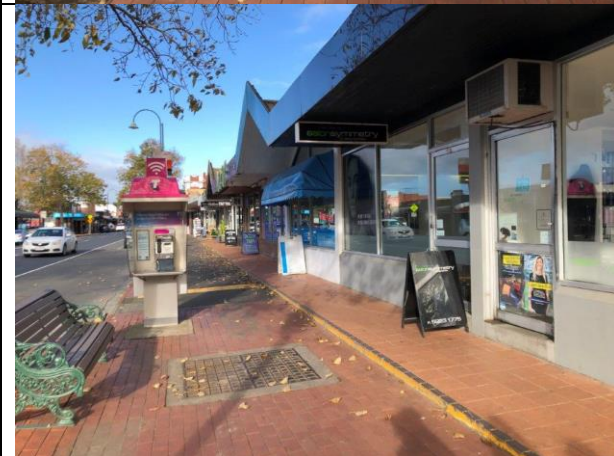
General view with raised section of retail frontage adjacent the footpath

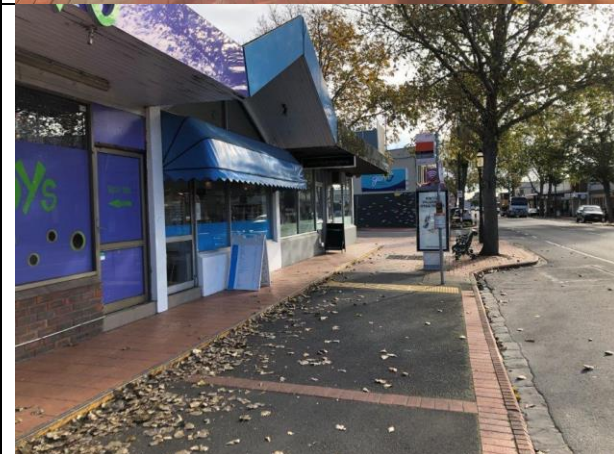
General view with raised section of retail frontage adjacent the footpath that has now changed to asphalt panels

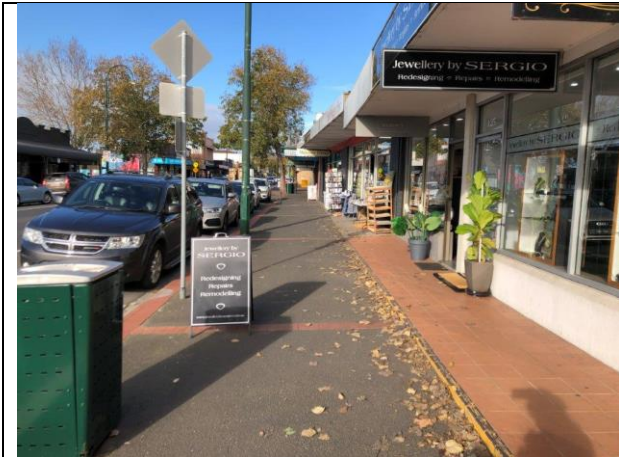
- × Leaf litter obscures step further
- × Footpath crossfalls 3.5%, in excess of 3% for asphalt surfaces

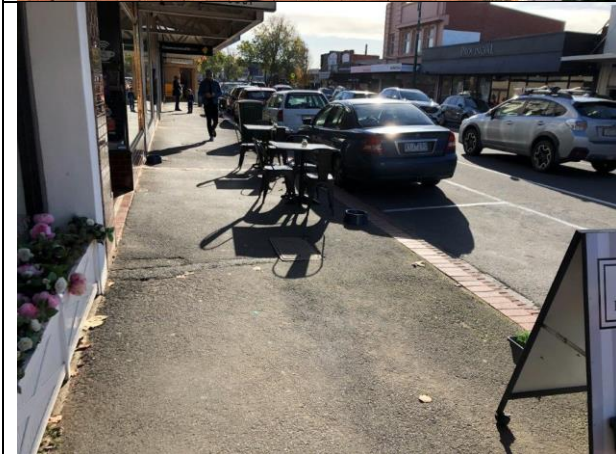
- × Some unevenness adjacent utility covers

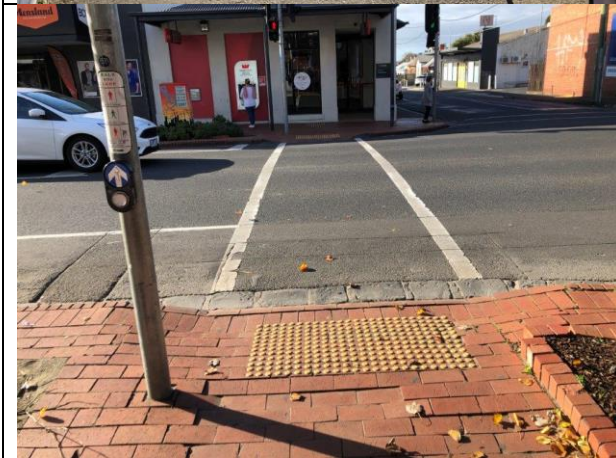
Controlled crossing across Pakington Street, footpath grades to carriageway, gradient approx. 5.2%

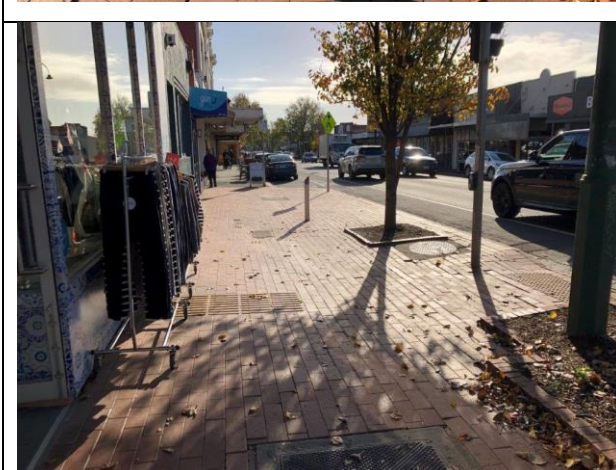
- × Incomplete directional TGSIs adjacent shop front

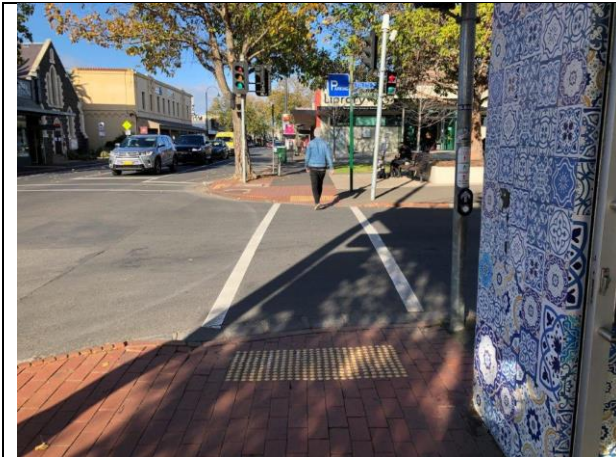
- × Controlled crossing across Albert Street, footpath grades to carriageway, gradient approx. 9.1%
- ✓ TGSIs aligned with path of travel
- ✓ TGSIs provided
- × Kerb cut not aligned with path of travel
- × TGSIs likely inadequate luminance contrast
- × Uneven brick surfacing
- × Cobbled kerb and lip edge

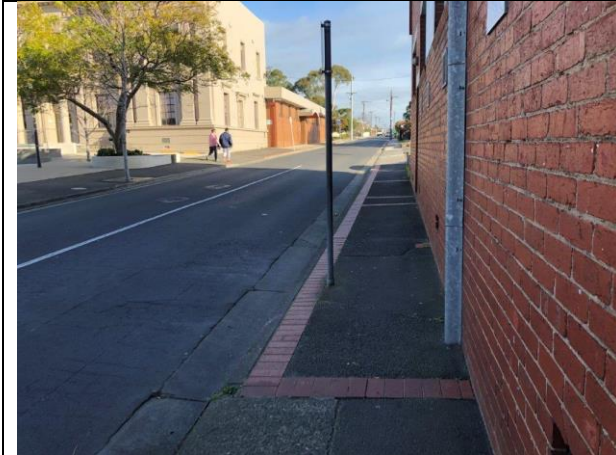
- × Footpath crossfalls 4.0%, in excess of 3% for asphalt surfaces.

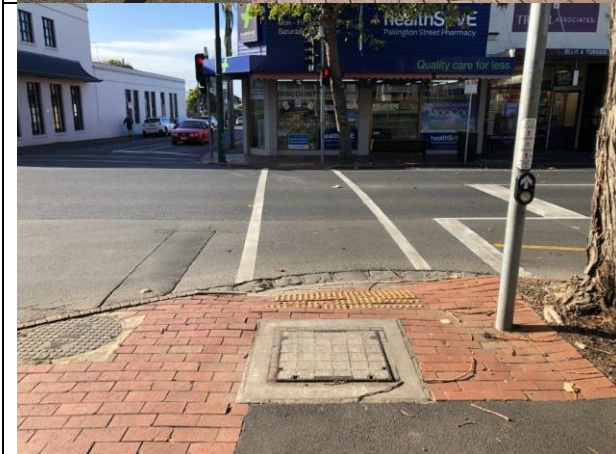
- Controlled crossing across Pakington Street.
- ✓ TGSIs aligned with path of travel
  - ✓ TGSIs provided
  - × Kerb cut not aligned with path of travel
  - × TGSIs poor luminance contrast
  - × TGSIs damaged
  - × Uneven footpath
  - × Cobbled kerb and lip edge

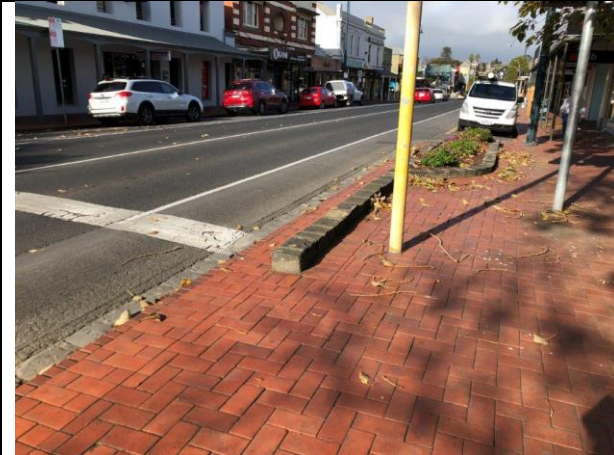
Adjacent to controlled crossing across towards Post Office.

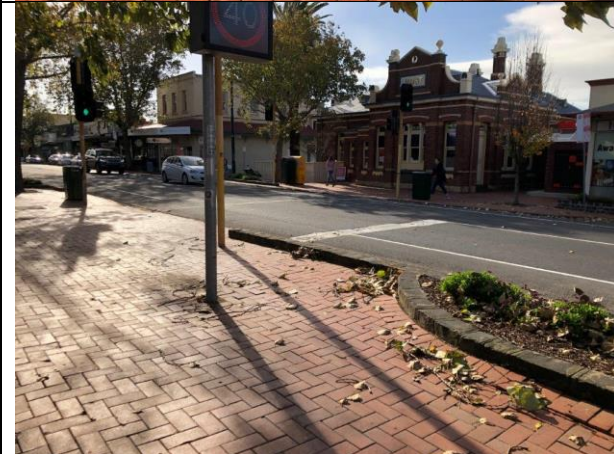
Adjacent to controlled crossing across towards Post Office.

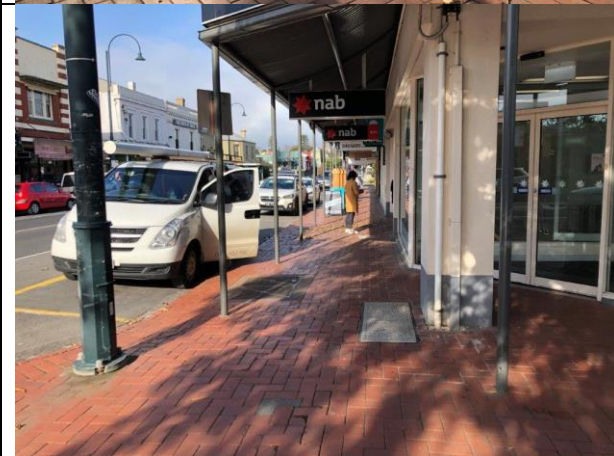
- × Planter edge extended to vehicle stop line - potential hazard or safety feature?

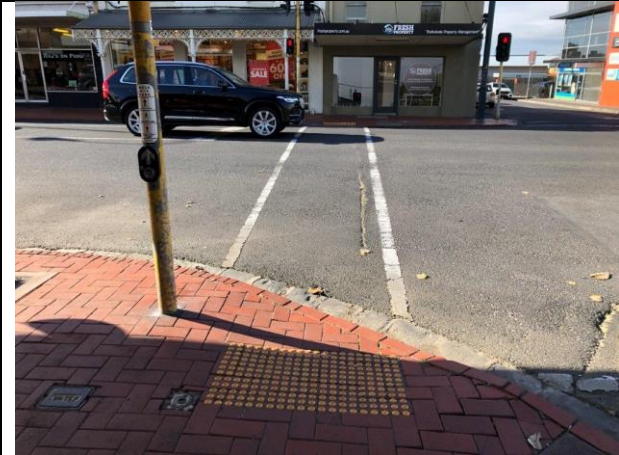
Controlled crossing across Pakington Street

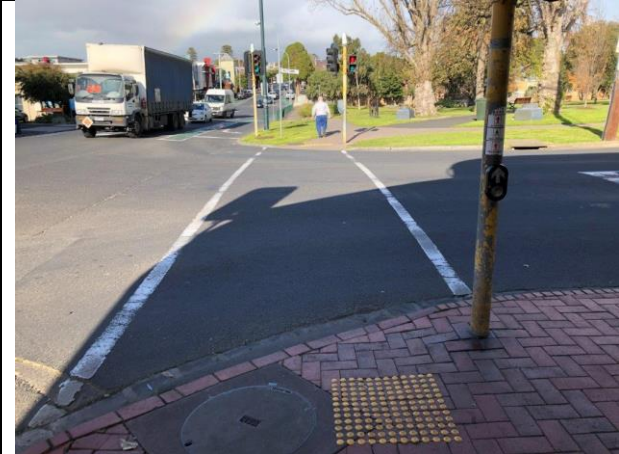
Controlled crossing across Autumn Street, footpath grades down to carriageway with gradient approx. 8.9%

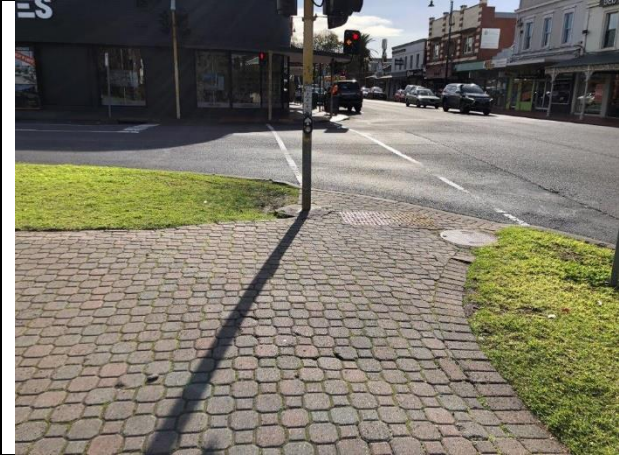
Controlled crossing across Autumn Street
