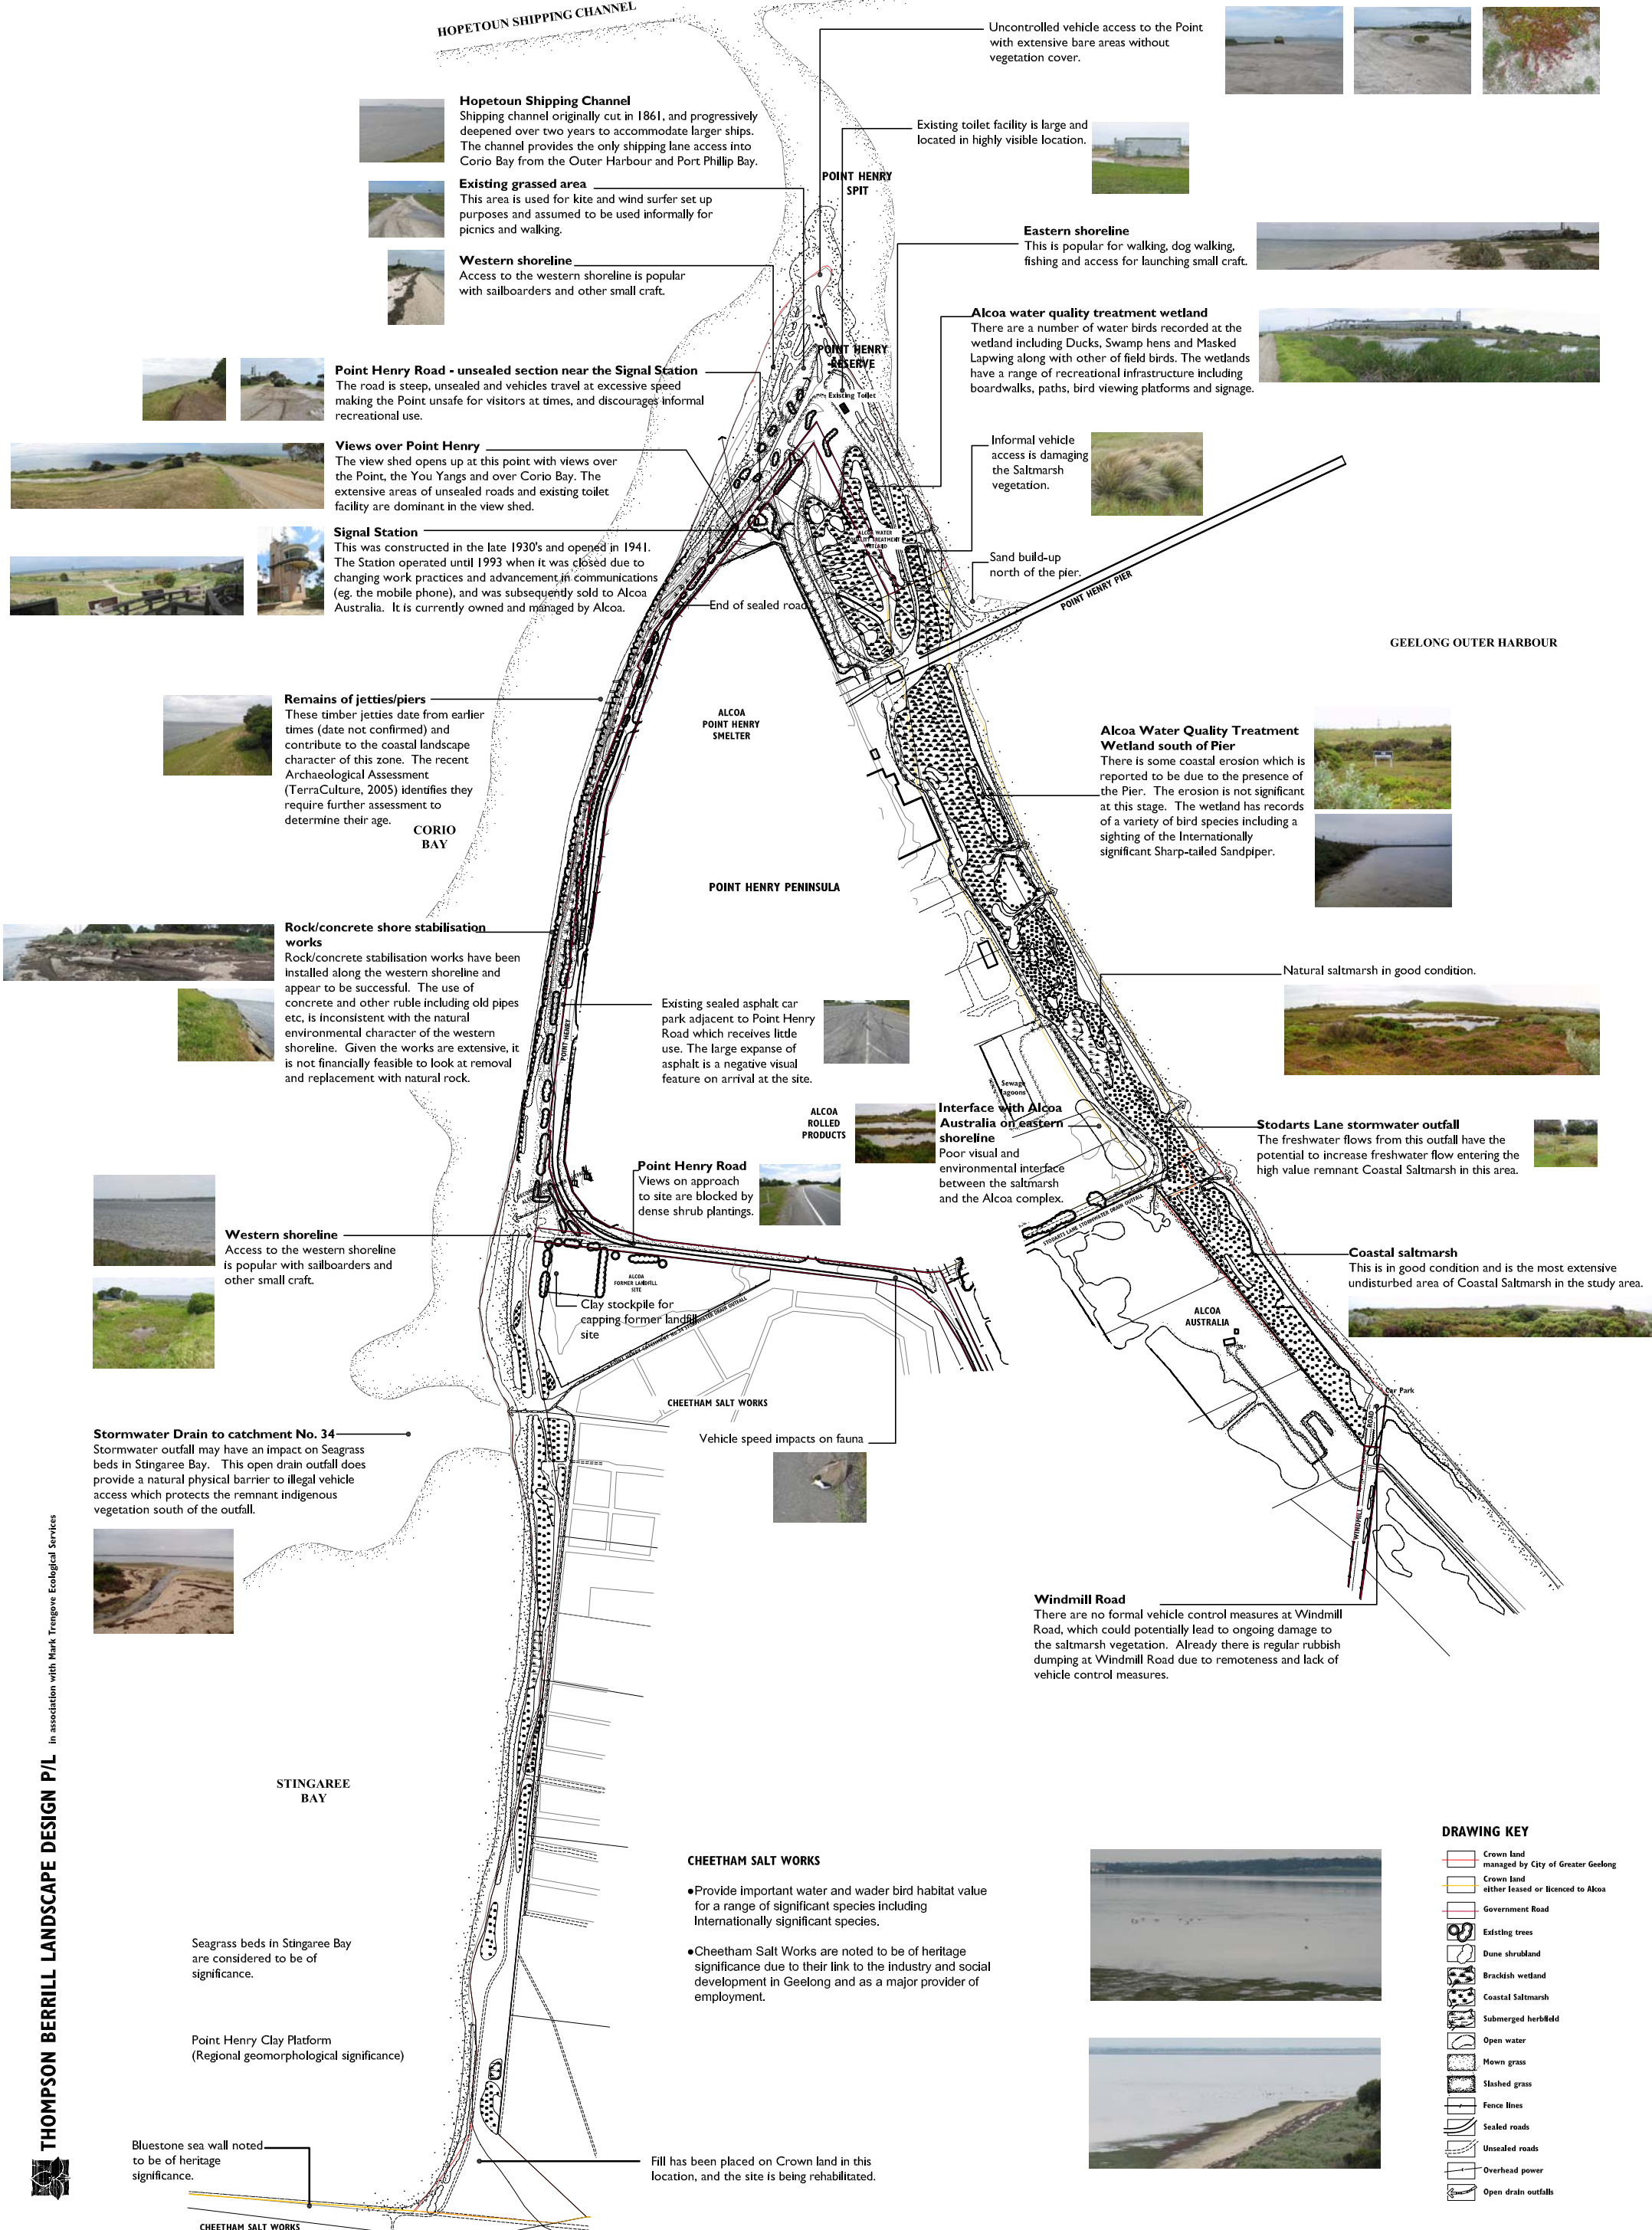
Hopetoun Shipping Channel
Shipping channel originally cut in 1861, and progressively deepened over two years to accommodate larger ships. The channel provides the only shipping lane access into Corio Bay from the Outer Harbour and Port Phillip Bay.

Existing grassed area
This area is used for kite and wind surfer set up purposes and assumed to be used informally for picnics and walking.

Western shoreline
Access to the western shoreline is popular with sailboarders and other small craft.

Point Henry Road - unsealed section near the Signal Station
The road is steep, unsealed and vehicles travel at excessive speed making the Point unsafe for visitors at times, and discourages informal recreational use.

Views over Point Henry
The view shed opens up at this point with views over the Point, the You Yongs and over Corio Bay. The extensive areas of unsealed roads and existing toilet facility are dominant in the view shed.

Signal Station
This was constructed in the late 1930's and opened in 1941. The Station operated until 1993 when it was closed due to changing work practices and advancement in communications (eg. the mobile phone), and was subsequently sold to Alcoa Australia. It is currently owned and managed by Alcoa.

Remains of jetties/piers
These timber jetties date from earlier times (date not confirmed) and contribute to the coastal landscape character of this zone. The recent Archaeological Assessment (TerraCulture, 2005) identifies they require further assessment to determine their age.

Rock/concrete shore stabilisation works
Rock/concrete stabilisation works have been installed along the western shoreline and appear to be successful. The use of concrete and other rubble including old pipes etc, is inconsistent with the natural environmental character of the western shoreline. Given the works are extensive, it is not financially feasible to look at removal and replacement with natural rock.

Stormwater Drain to catchment No. 34
Stormwater outfall may have an impact on Seagrass beds in Stingaree Bay. This open drain outfall does provide a natural physical barrier to illegal vehicle access which protects the remnant indigenous vegetation south of the outfall.

Seagrass beds in Stingaree Bay are considered to be of significance.

Point Henry Clay Platform (Regional geomorphological significance)

Bluestone sea wall noted to be of heritage significance.

Fill has been placed on Crown land in this location, and the site is being rehabilitated.

Uncontrolled vehicle access to the Point with extensive bare areas without vegetation cover.

Existing toilet facility is large and located in highly visible location.

Eastern shoreline
This is popular for walking, dog walking, fishing and access for launching small craft.

Alcoa water quality treatment wetland
There are a number of water birds recorded at the wetland including Ducks, Swamp hens and Masked Lapwing along with other of field birds. The wetlands have a range of recreational infrastructure including boardwalks, paths, bird viewing platforms and signage.

Informal vehicle access is damaging the Saltmarsh vegetation.

Sand build-up north of the pier.

Alcoa Water Quality Treatment Wetland south of Pier
There is some coastal erosion which is reported to be due to the presence of the Pier. The erosion is not significant at this stage. The wetland has records of a variety of bird species including a sighting of the Internationally significant Sharp-tailed Sandpiper.

Natural saltmarsh in good condition.

Stodarts Lane stormwater outfall
The freshwater flows from this outfall have the potential to increase freshwater flow entering the high value remnant Coastal Saltmarsh in this area.

Coastal saltmarsh
This is in good condition and is the most extensive undisturbed area of Coastal Saltmarsh in the study area.

Windmill Road
There are no formal vehicle control measures at Windmill Road, which could potentially lead to ongoing damage to the saltmarsh vegetation. Already there is regular rubbish dumping at Windmill Road due to remoteness and lack of vehicle control measures.
