Geelong Sale Yards

Weddell Road, North Geelong

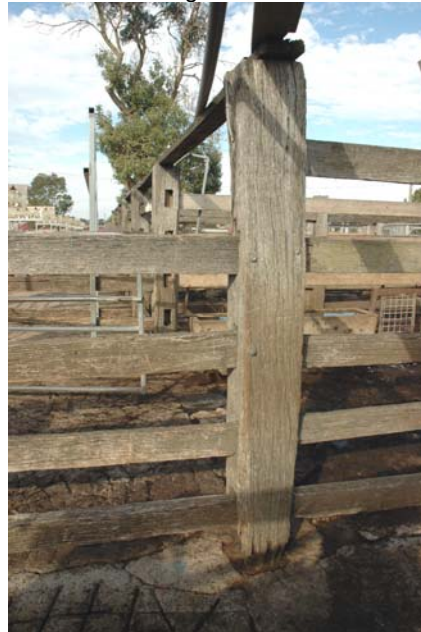
Photo 3.17: Detail of early timber post & rail pen fence. Note the rotting (needling) base of the post and weathered condition of the rails.

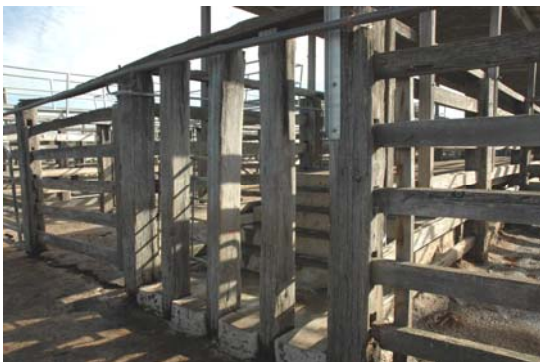
Photo 3.18: Detail of timber post & rail fence and post barrier at the eastern end of the northern covered walkway.

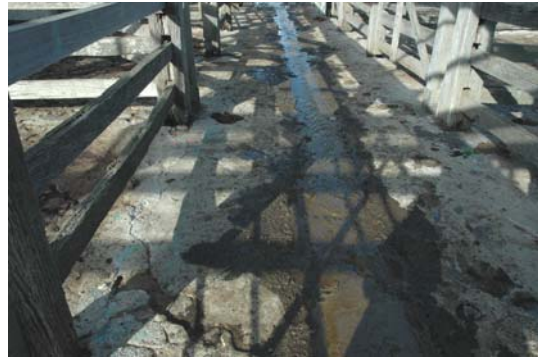
Photo 3.21: Detail of internal way showing invert drain. The concrete slurry over the bluestone has been introduced. Note the cracking and breaking down of the concrete.

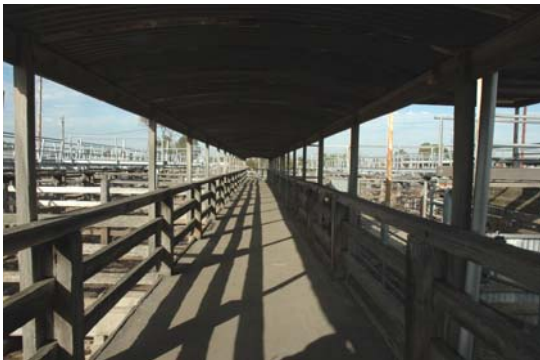
Photo 3.22: Detail of covered walkway looking east.

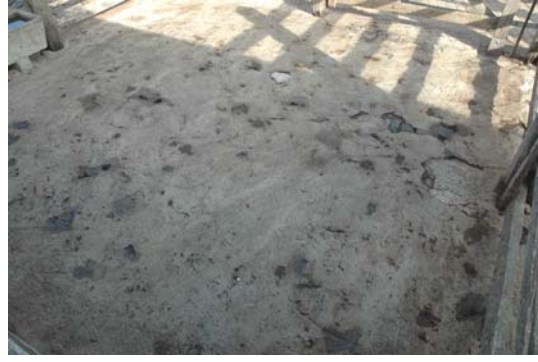
Photo 3.29: Detail of early bluestone paving with introduced concrete slurry over. Note the cracks in the concrete.

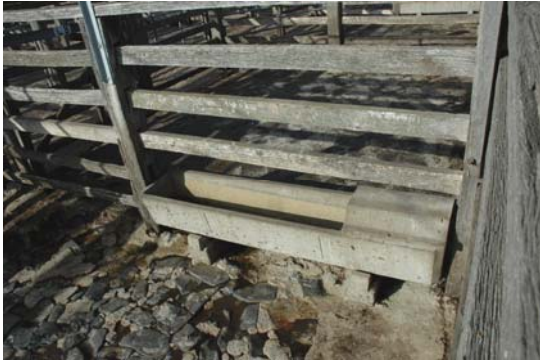
Photo 3.30: Detail of introduced concrete trough in cattle pen.

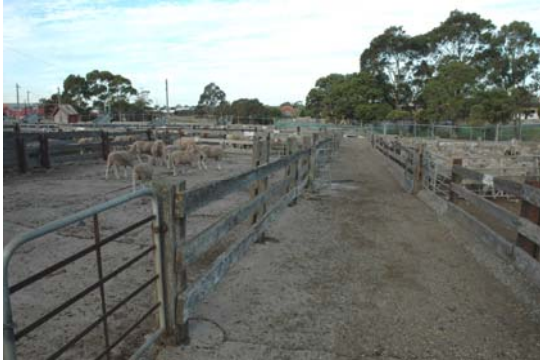
Photo 3.34: Detail of early timber posts with introduced timber rails bolts to the sides of the posts. These rails have replaced the original rails that were set in the vertical slots of the posts.

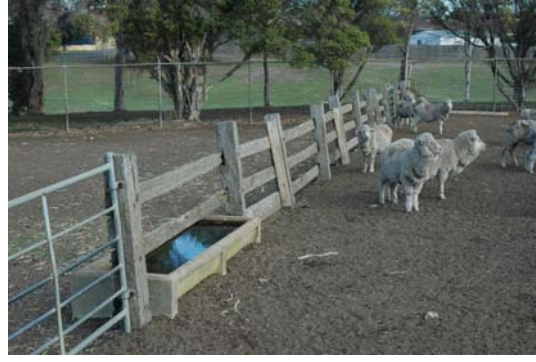
Photo 3.35: Detail of early timber post and rail fencing, near the north-east corner.

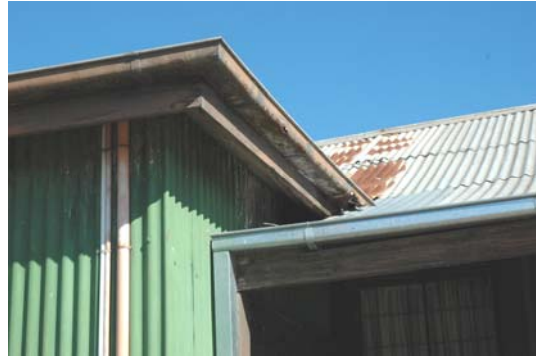
Photo 3.61: Market Offices building, east elevation. Detail of junction of hipped window and main traversing roof. Note the completely rusted gutters on the projecting hipped wing.

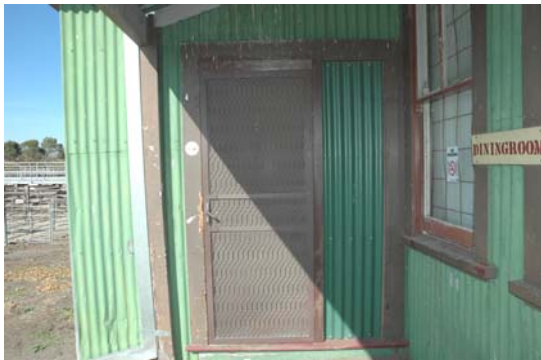
Photo 3.62: Market Offices building, east elevation. Refreshment Room door detail (north face under verandah).

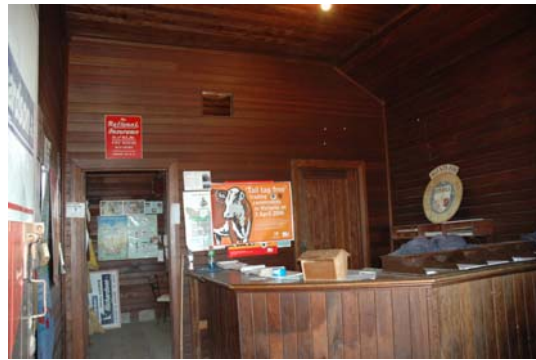
Photo 3.81: Interior, H.F. Richardson office, looking west. Note the early stained timber v-jointed ceiling and walls.

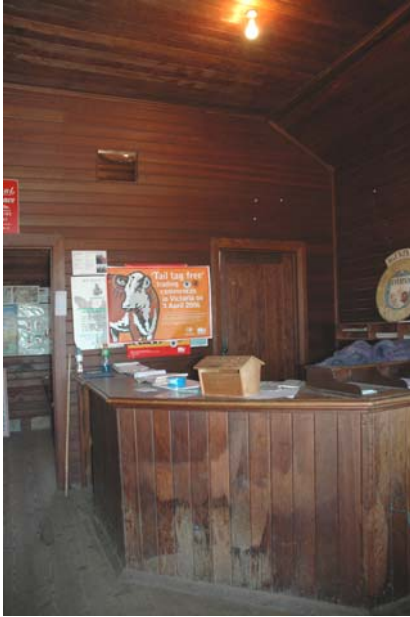
Photo 3.82: Interior, H.F. Richardson office. Note the v-jointed timber ceiling and the built-in sales bench.

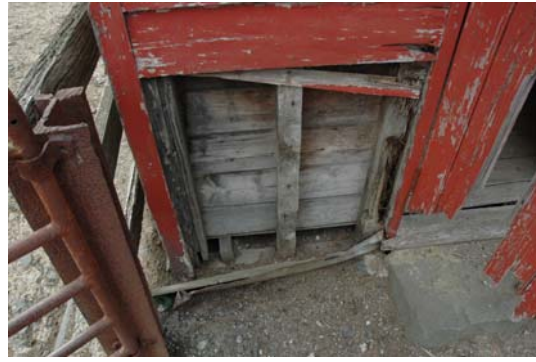
Photo 3.137: Former Caretaker's Cottage, south elevation. Detail of rotted and missing timber weatherboards west of door opening.

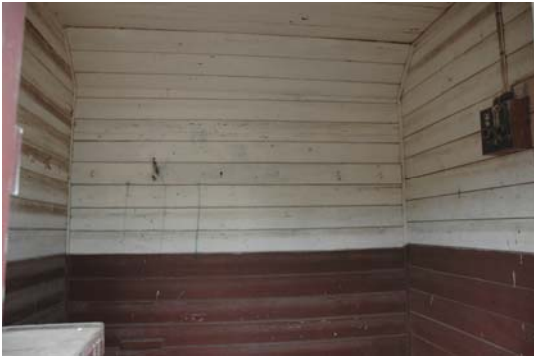
Photo 3.138: Interior, former Caretaker's Cottage. Wall detail.
